ENGINEERING GEOLOGICAL MAP OF CHORAGHBYUR LANDSLIDE SITE

The fragment is taken from the Report on Project Implemented by the Ministry of Emergency Situations, 2005.

Recommendations on Priority Measures for Security Insuring of the Burial Ground (done by Mr. R. Yadoyan)

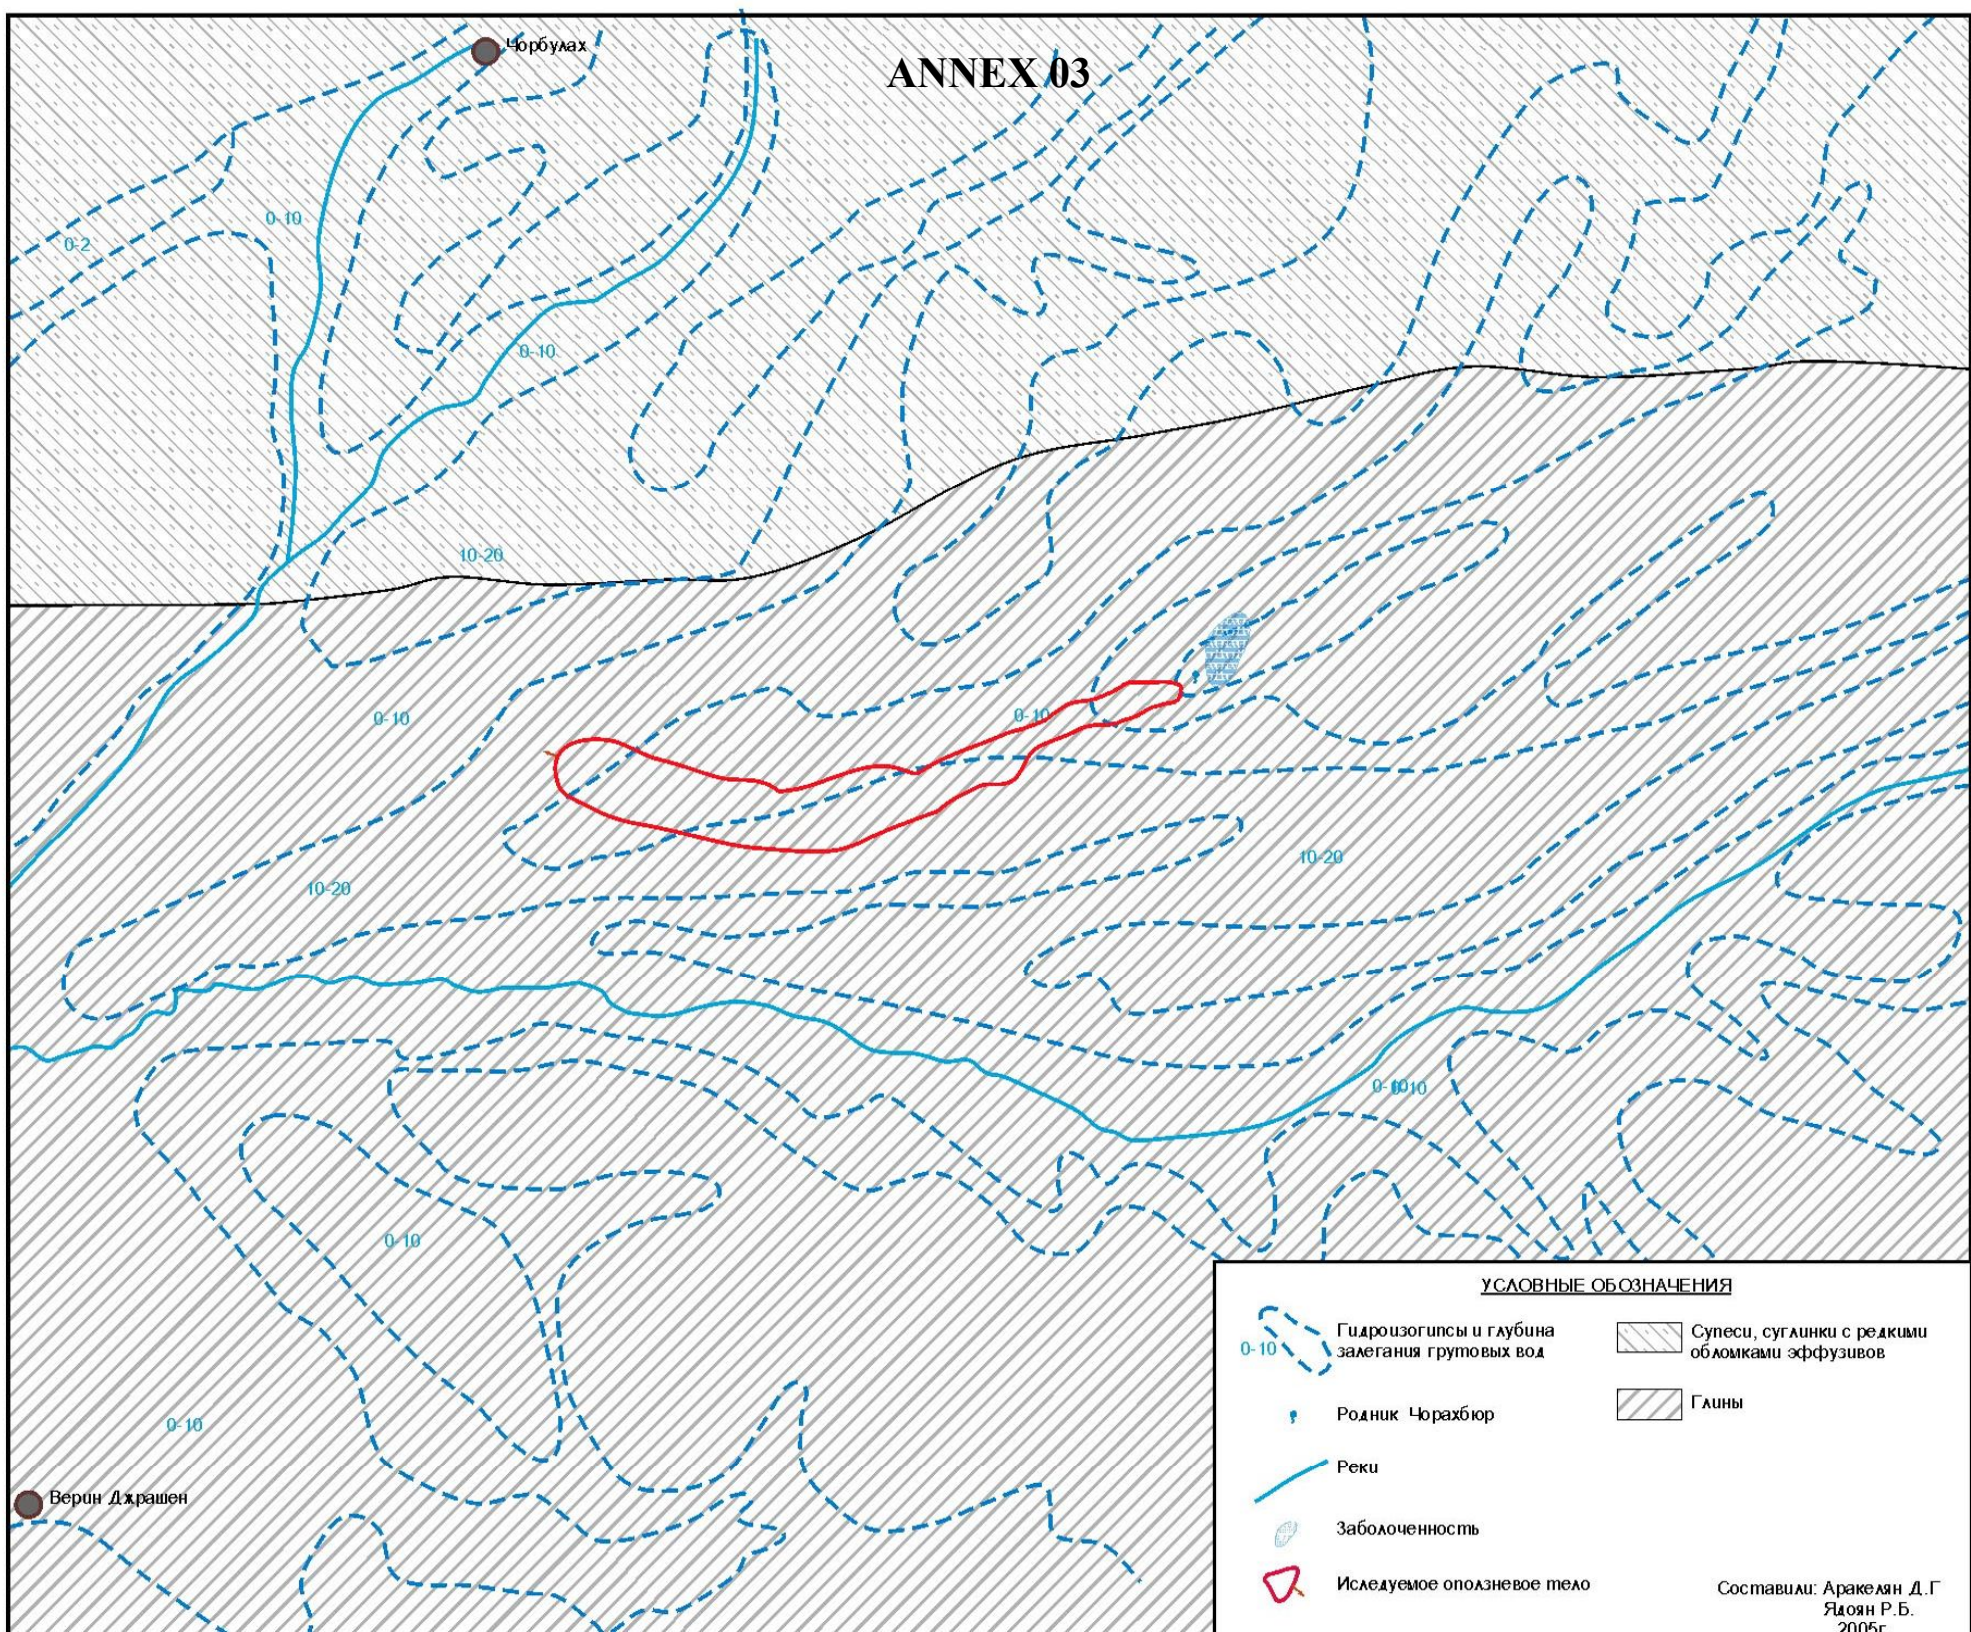
The water table contours and the depth of occurrence of underground water

Investigated landslide body

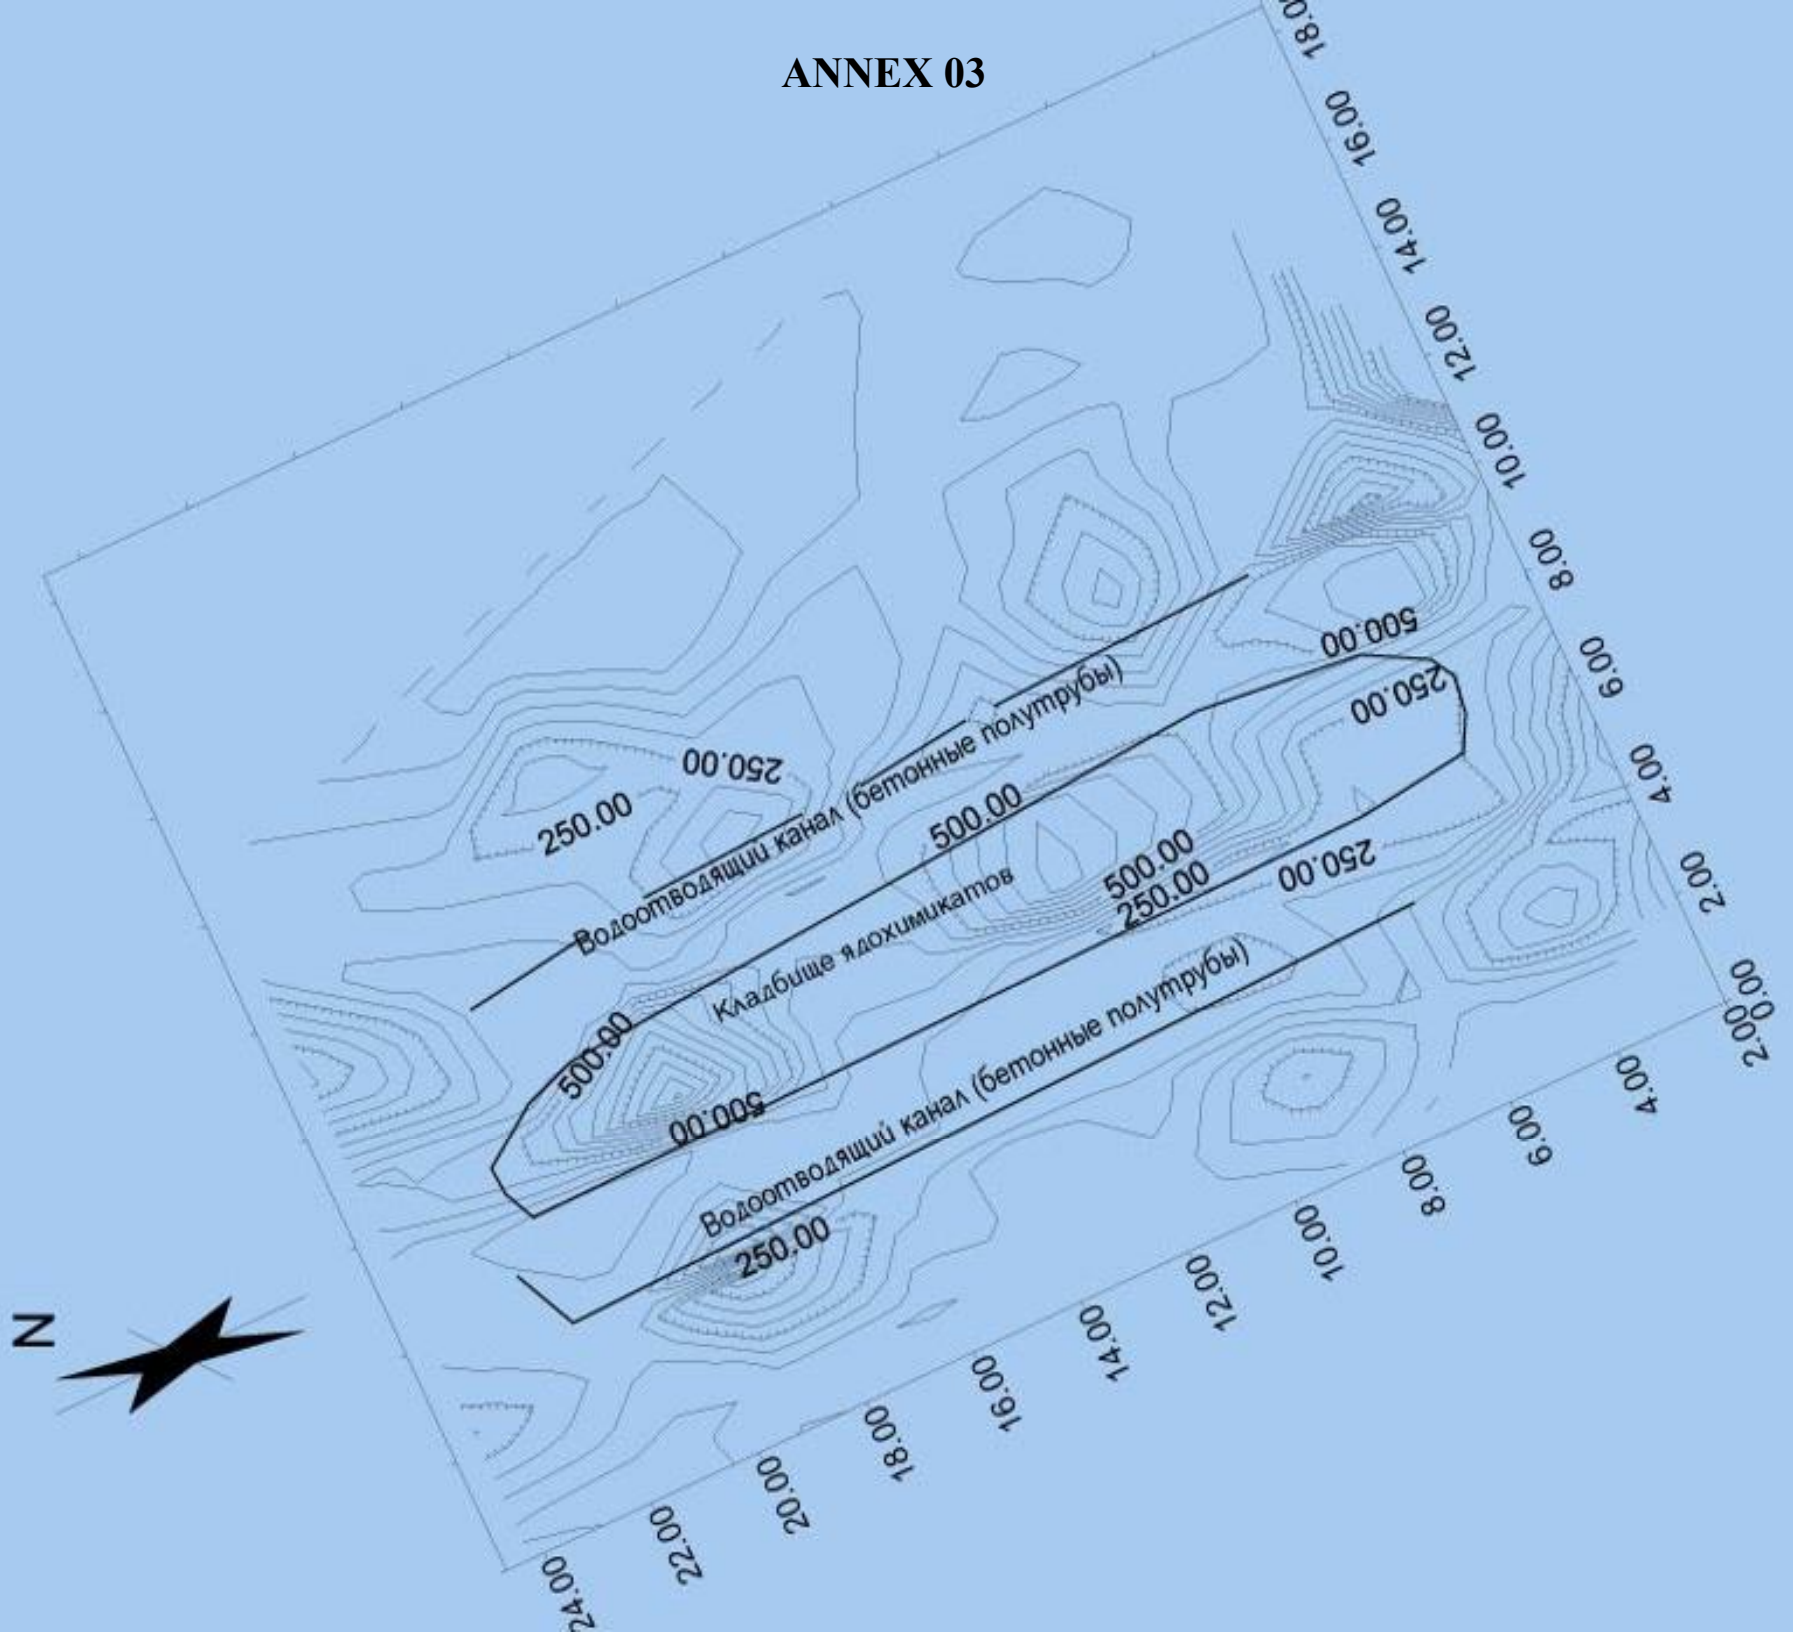
Рис. 3. План территории с расположением объектов, подлежащих ликвидации, и объектов, подлежащих консервации.

Catch water drain (concrete semi-pipes)

Burial ground

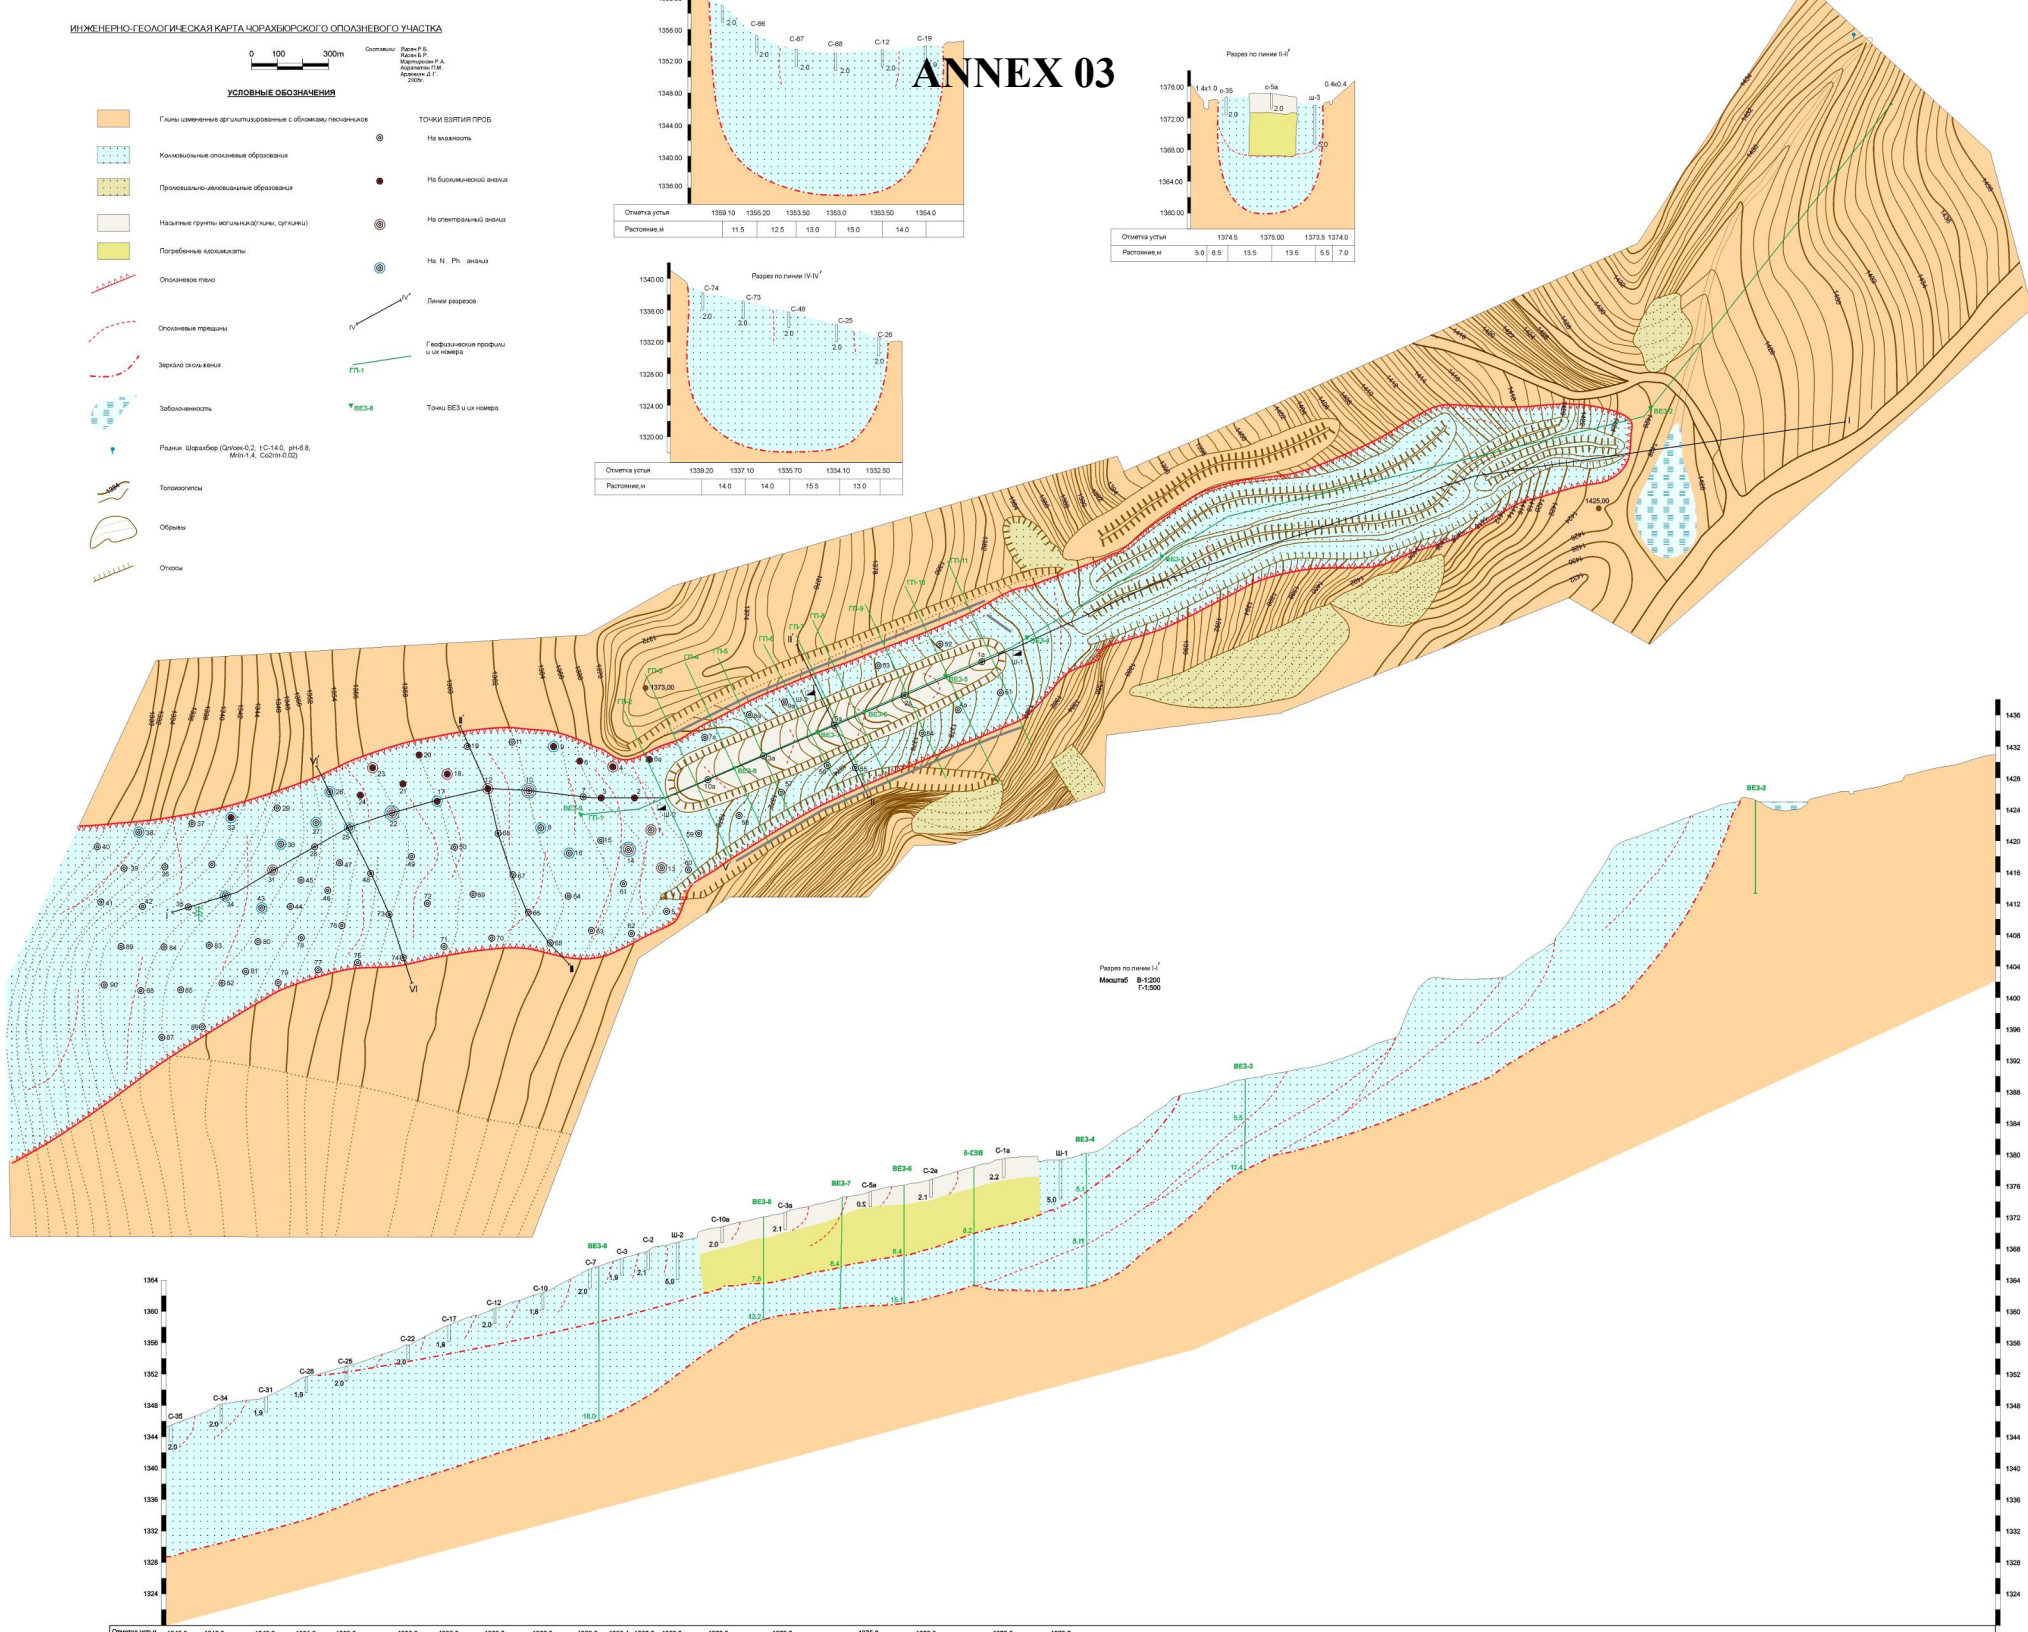
Разрез по линии I-I'
 Масштаб 1:1200
 Г.1920

Разрез по линии I-I'

View taken along line I-I'

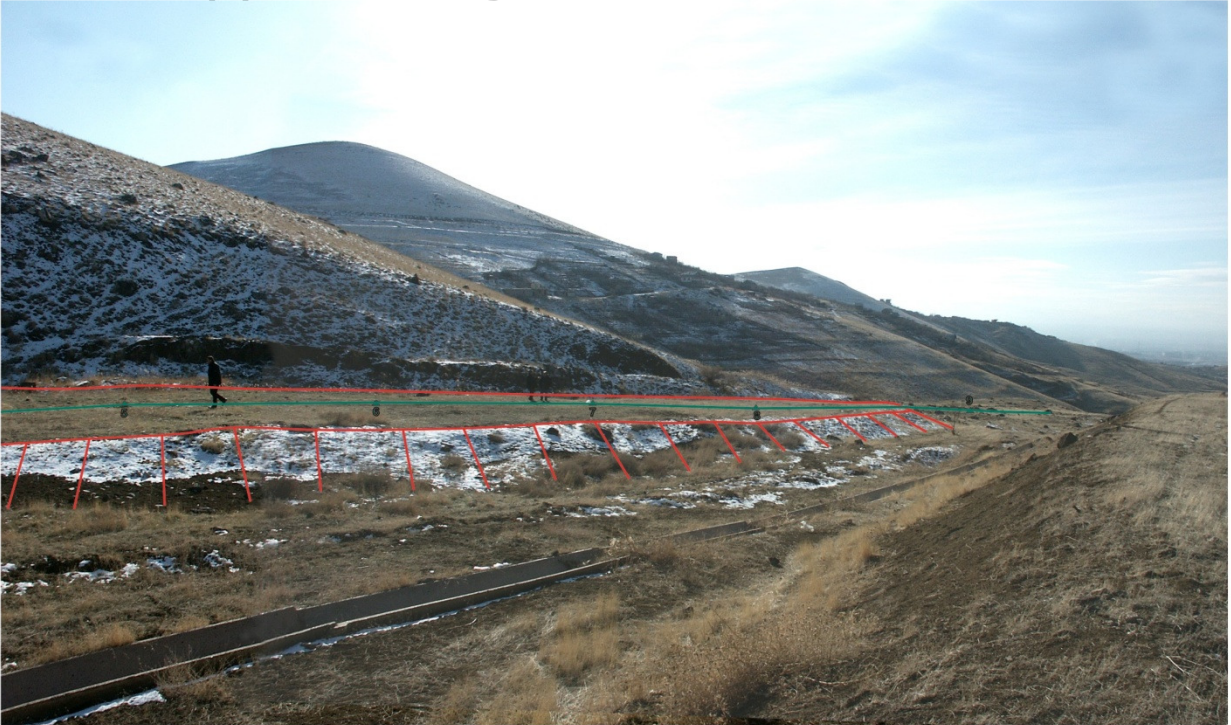
Նկ.1. Երկրաֆիզիկական երկայնական 0-0 պրոֆիլը և ՈՒԷԶ-ի կետերի դիրքը թունաքիմիկատների գերեզմանոցում

Photo 1. The location of geophysical longitudinal 00 profile and $\Omega\Gamma\Xi\Omega$ points at the landfill site

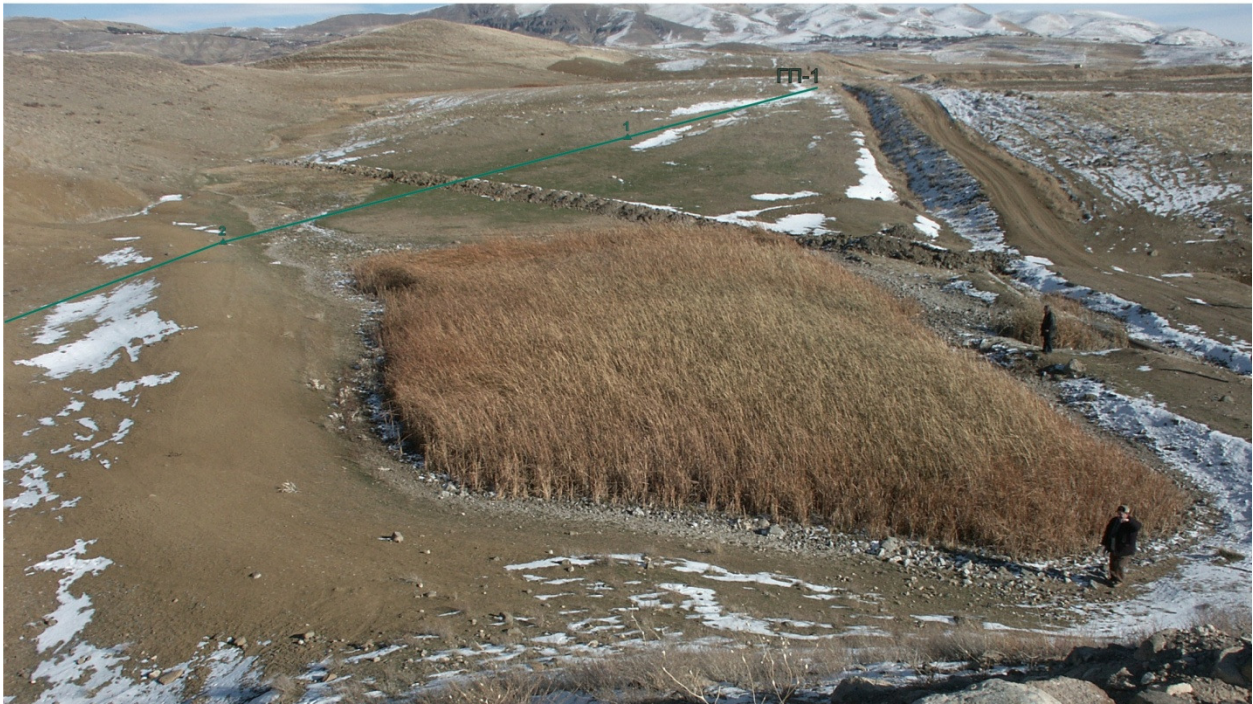
Նկ. 2. Երկրաֆիզիկական երկայնական 0-0 պրոֆիլի սկիզբը

Photo 2. The starting of the geophysical longitudinal 00 profile

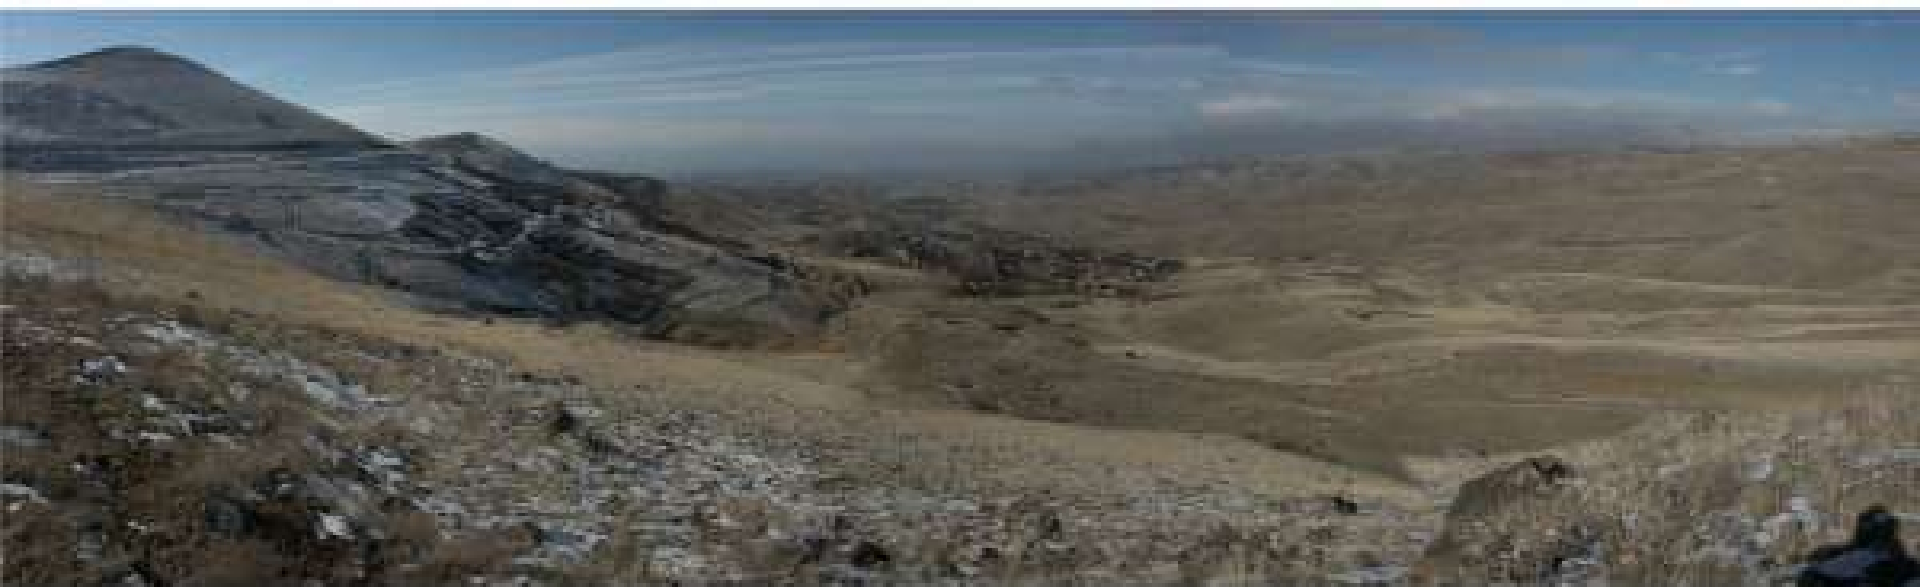
Նկ. 2: Սողանքային ճարձնի միջին և ստորին (լեզվակային) հատվածները:

7. Multiple remnants of the concrete and metal posts of the surrounding of the burial ground have been found
8. The tongue of the landslide is more active and it is notable for multiple transverse clefts (0,1-1m); according to the geophysical activities it is predicted that the landslide will start to become active in the head part, where the boggy area is located.

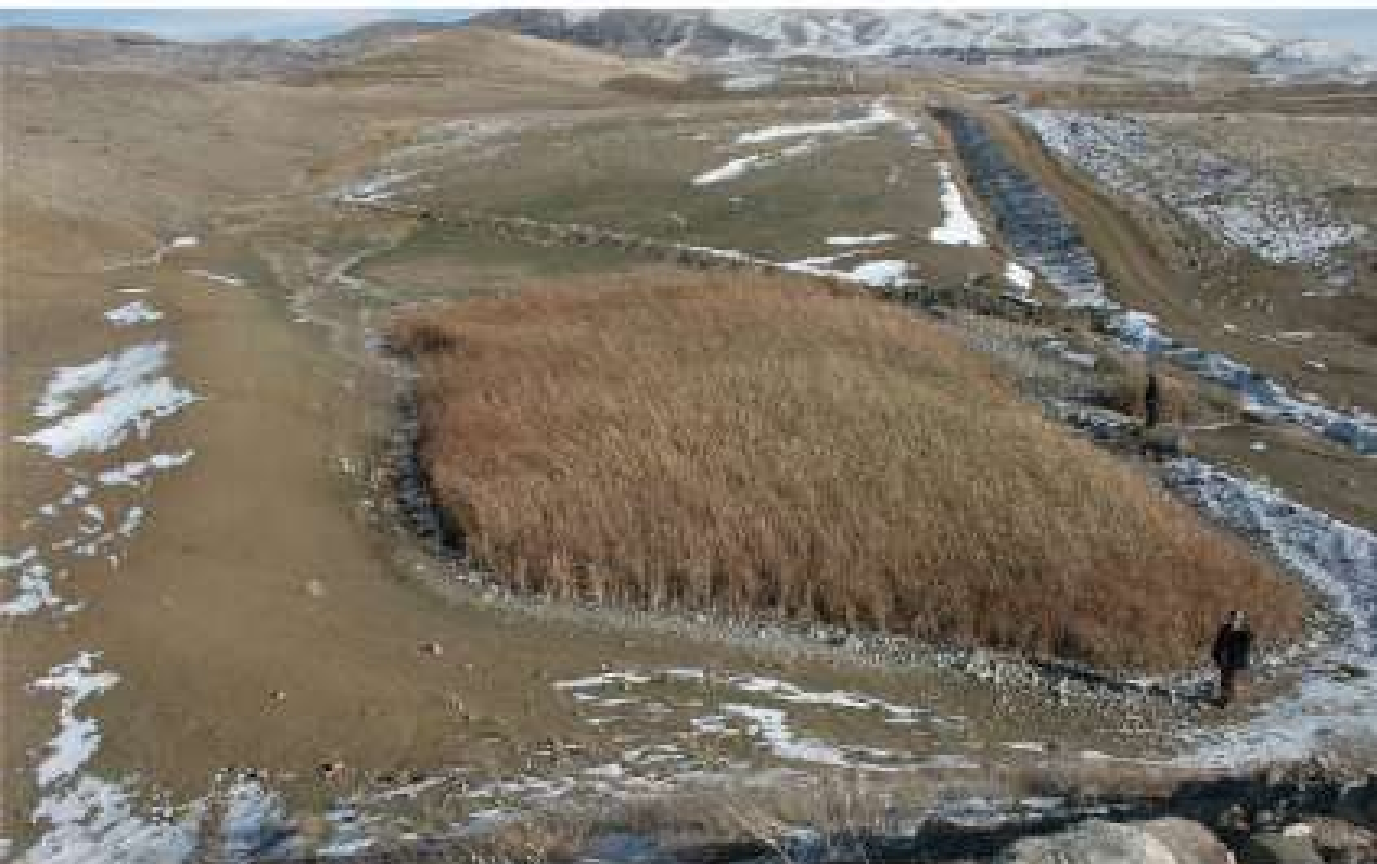
Նկ. 9. Սողանքային վերին տեղամասի ճահճակալումը:

2. Elimination of the swampy area located on the head part of the landslide; lifting of the soil cover
3. Construction of a 30m long waterproof wall barrier/wall fence (in the soil) at a distance of 10-15m

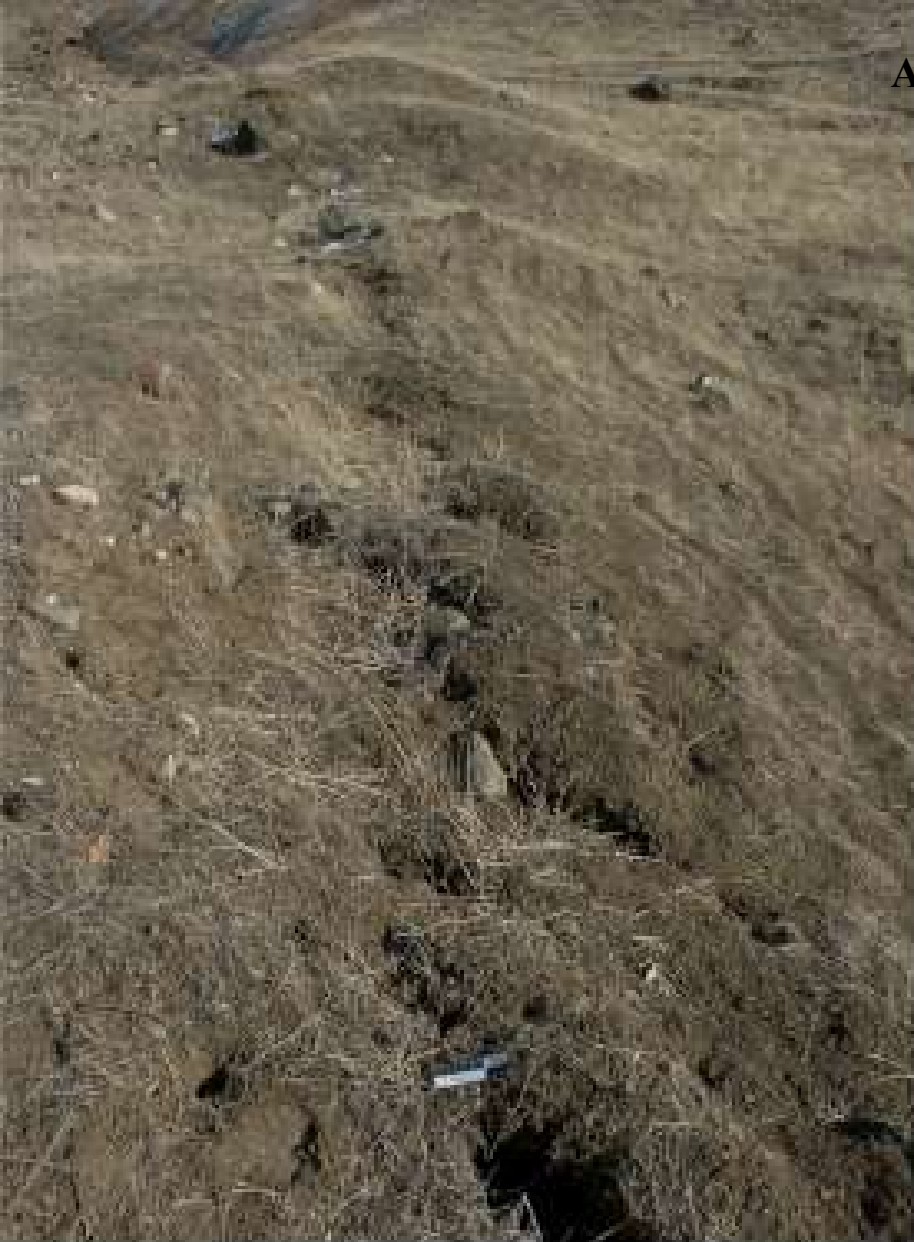
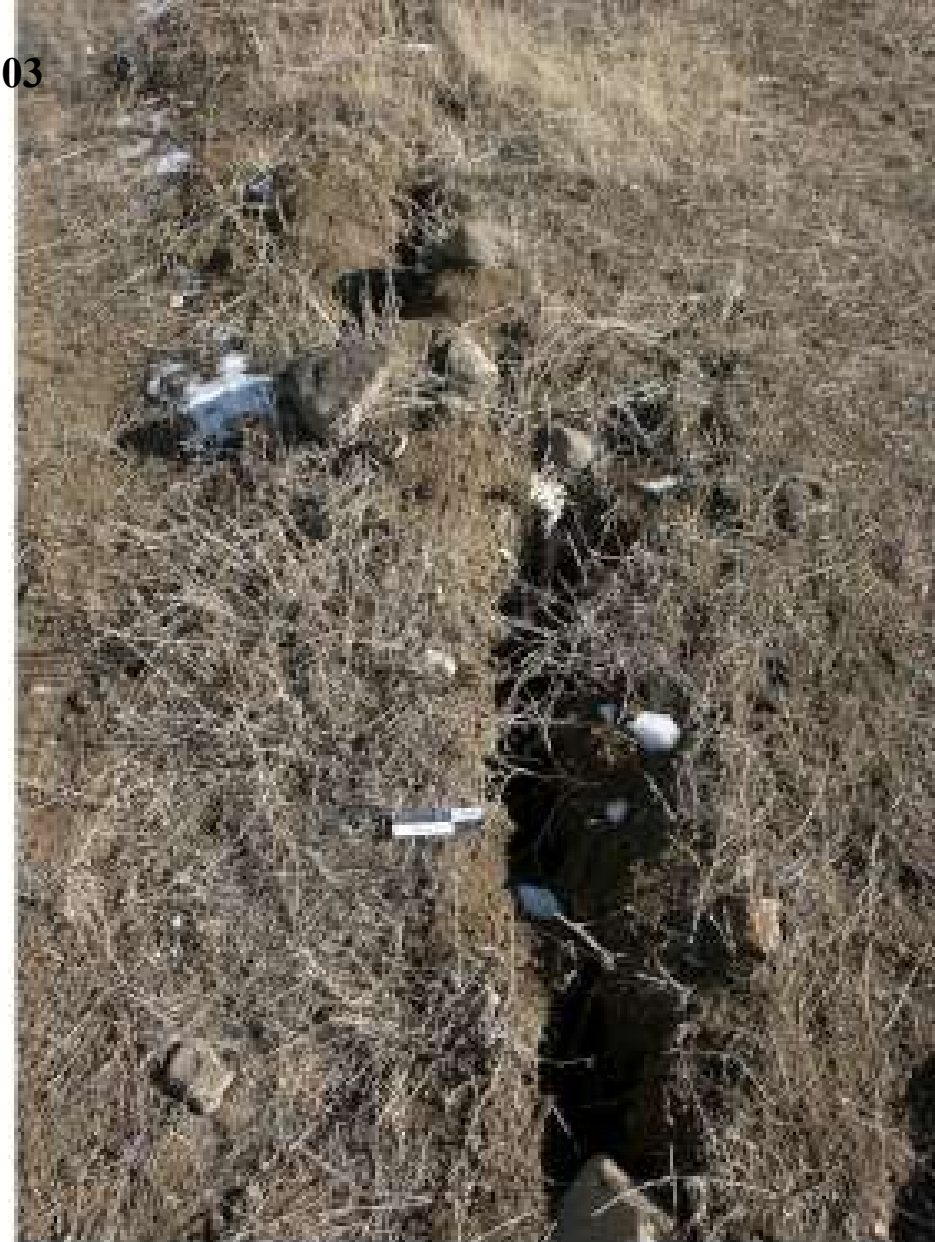
Նկ. 10,11. Տեղաշարժման և սեխման սողանքային ճաքեր:

8. Refilling and leveling of all cracks, clefts and gaps. By the approximate calculations it is 400 m^3 , out of which 100 m^3 is clayey-sandy-polymeric-mineral.
9. Provision of the integrity of the fence, cleanness of the concrete drains and firmness of all other constructions
10. Samplings, analyses, observation and monitoring of the velocity of the landslide and migration of the pesticides according to the methods available

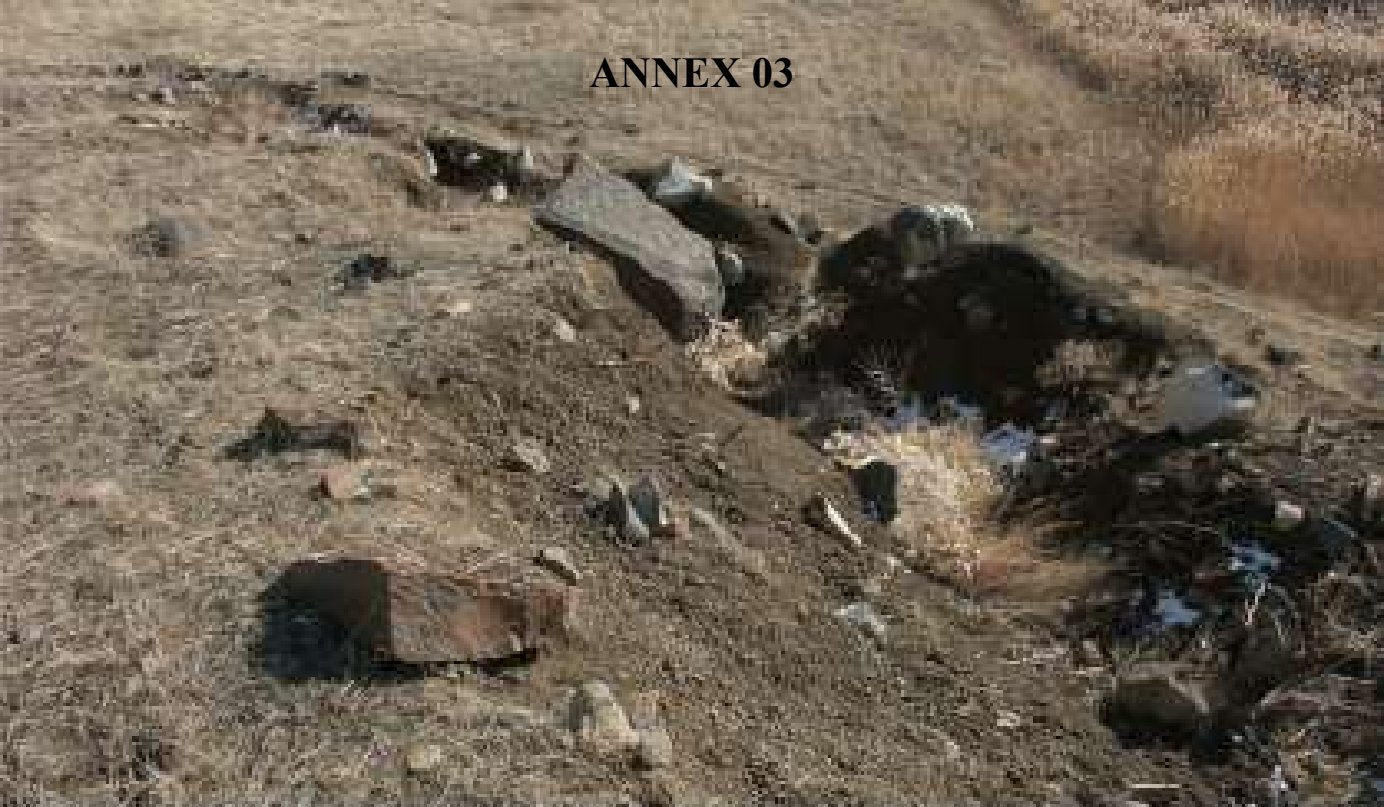
Նկ. 14. Անջատման ճաքեր:

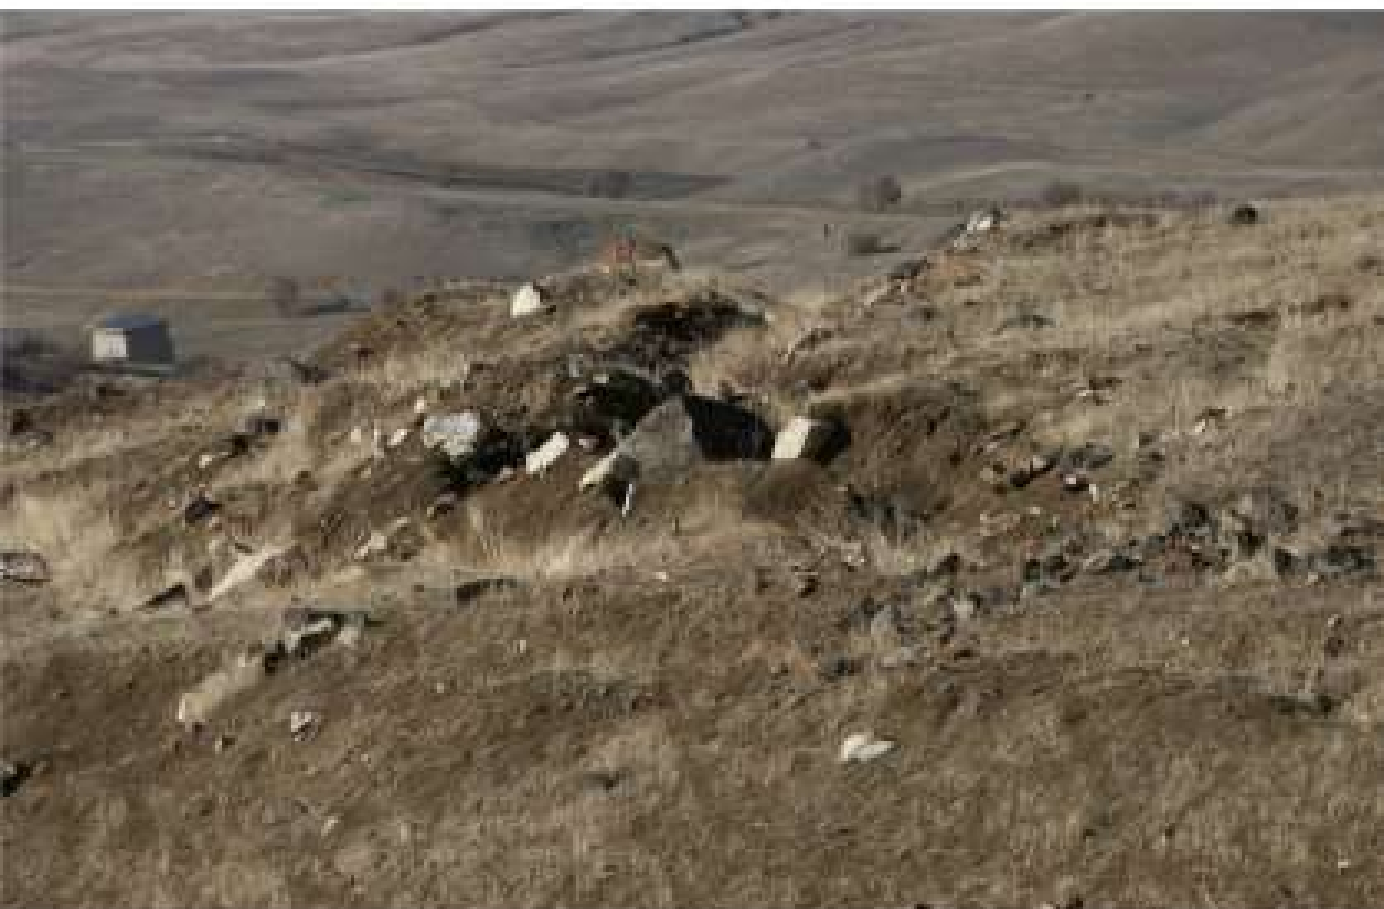
Նկ. 15. Անջատված զանգվածը (եզվակային հատվածում):

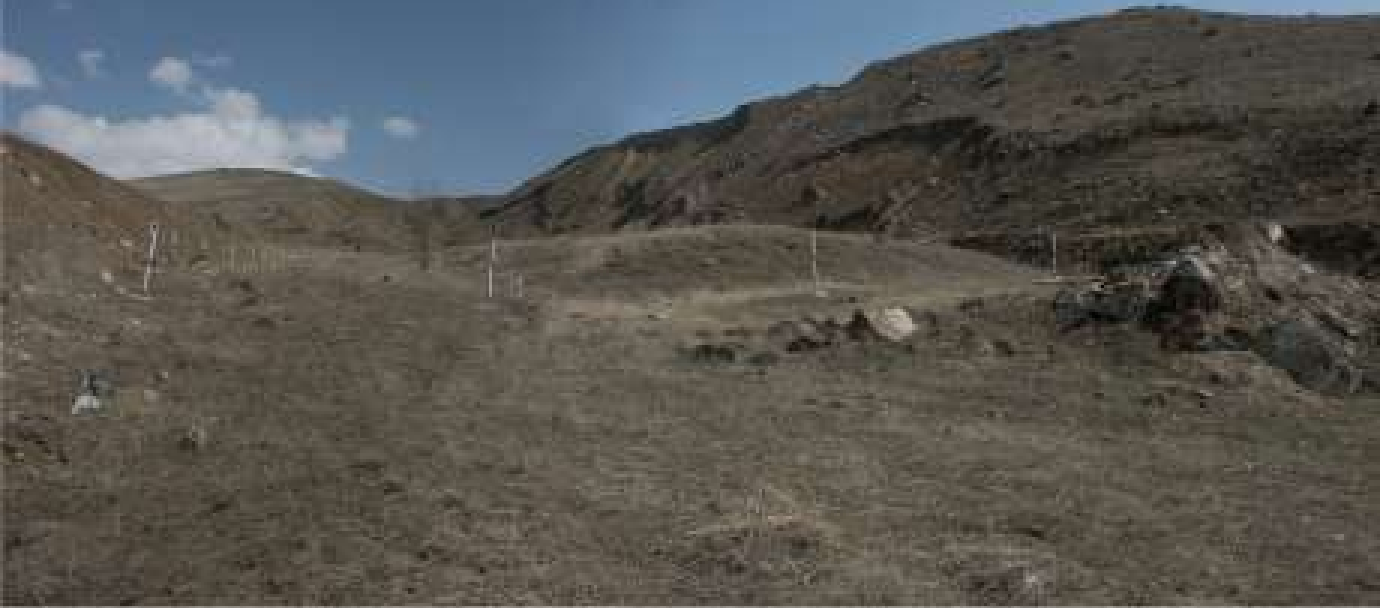
Նկ. 16. Թունաքիմիկատների գերեզմանոցի տեսքը ցանցապատումից հետո:

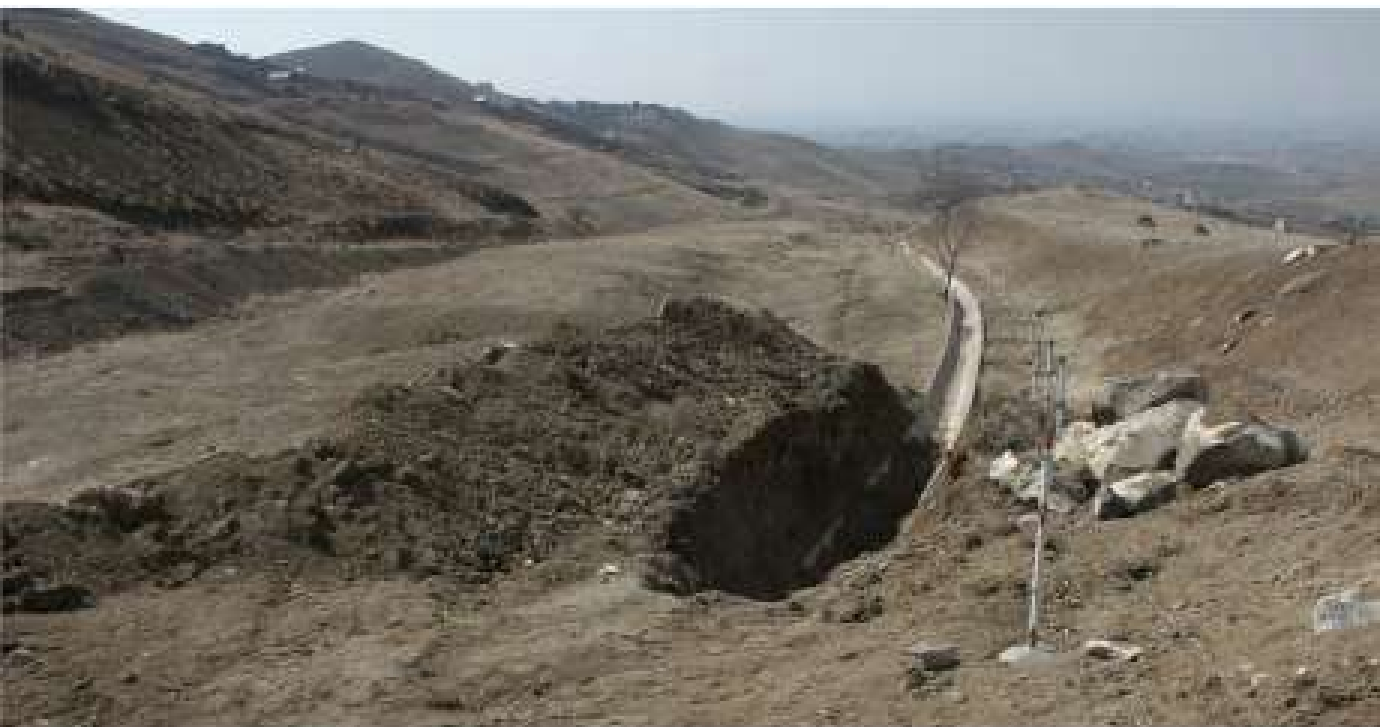
Նկ. 17. Թունաքիմիկատների գերեզմանոցը և ջրհեռացման համակարգը:

12. The main restoration works of the concrete drains and the fencing of the burial ground are over
13. It is proved that the danger comes only from the possible spread of the content of the burial ground, and that no other dangerous compounds were observed in the
